**EP 0 679 817 B1**

**EUROPEAN PATENT SPECIFICATION**

(54) **Drum brake device**

(73) Proprietor: **NISSHINBO INDUSTRIES INC.**  
**Chuo-ku, Tokyo (JP)**

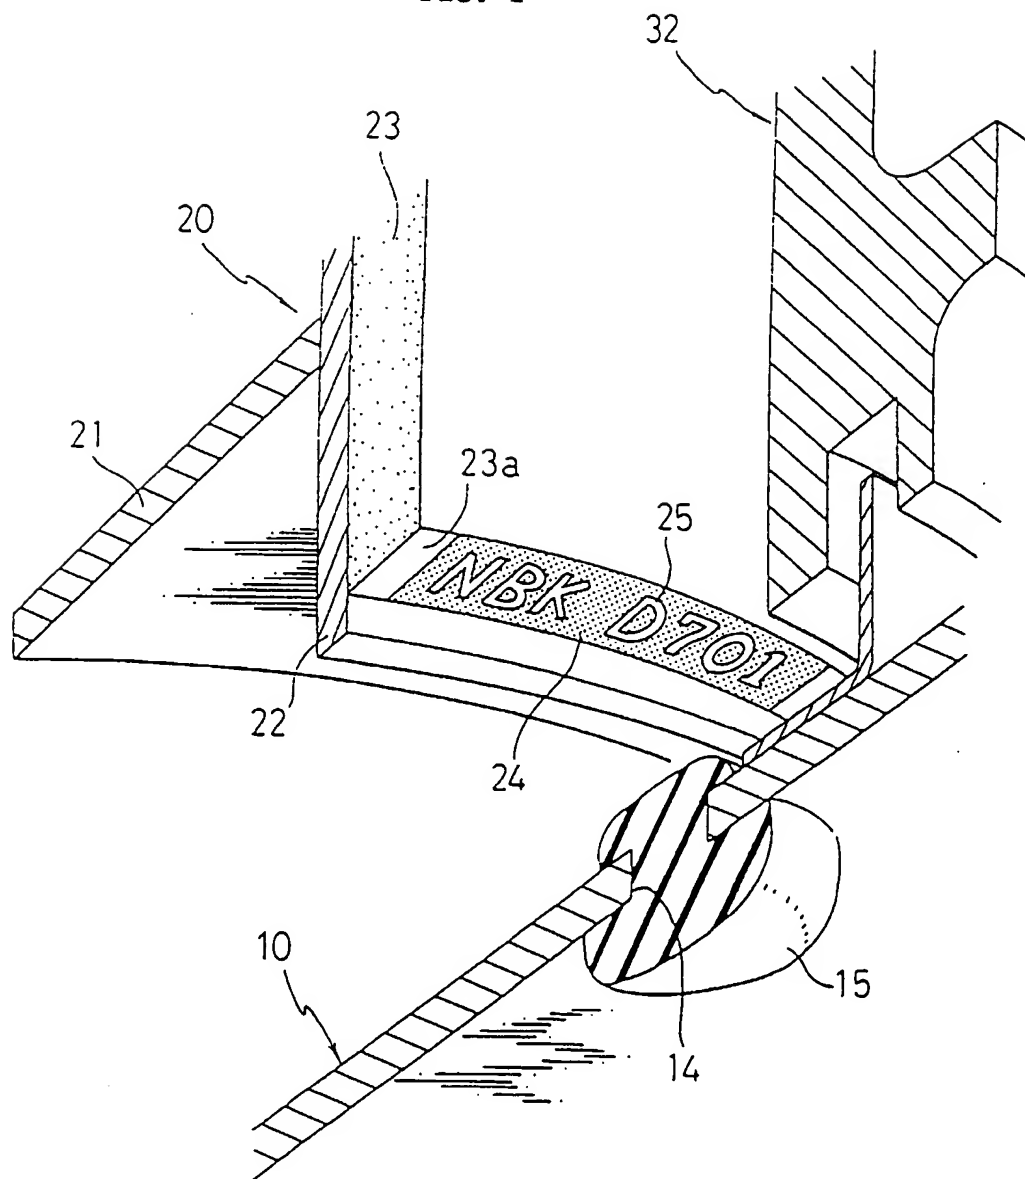
FIG. 1

- Fig. 1 is a perspective view of the drum brake device according to a first embodiment in which a portion of the device has been omitted;
- Fig. 2 is a cross section view of the peripheral edge of the drum brake device according to the embodiment;
- Fig. 3 is a plan view of the drum brake device according to the embodiment;
- Fig. 4 is an expanded diagram of a portion of a brake shoe;
- Fig. 5 is an expanded diagram of a portion of a brake shoe in order to explain another embodiment of the invention in which the coloured strip has a different depth.

[0024] As shown in Fig. 1 and Fig. 2, in the drum brake device of the present embodiment an inspection hole 14 is bored at the required position on the backplate 10 corresponding to the wear threshold limit value or maximum abradable portion of the lining 23. This inspection hole 14 enables a visual inspection of the amount of wear in the lining 23. Since the coloured strip 24 and the code 25 are positioned so that they correspond to the wear threshold limit value or maximum abradable portion of the lining, they can visually be inspected through the inspection hole 14, wherein no additional hole need be bored.

5 [0017] On the side of the brake cylinder 11, an automatic clearance adjustment mechanism 30 is set between the two brake shoes 20, which adjustment mechanism 30 automatically adjusts the clearance between the brake shoes 20 and a brake drum 32 (see Fig. 1) as a function of the amount of wear in a lining 23 of the brake shoe 20. This adjustment mechanism 30 is not restricted to a strut type as shown in the diagram, but can be of any conventional configuration.

[0025] Such an inspection hole 14 is usually covered by a grommet 15 in order to prevent the penetration of water and dust, which grommet 15 can be removed to visually examine the coloured strip 24 and the code 25. The inspection hole 14 is not restricted to an existing hole, and a further hole can be bored in the backplate 10 in a position facing the coloured strip 24 and the code 25.

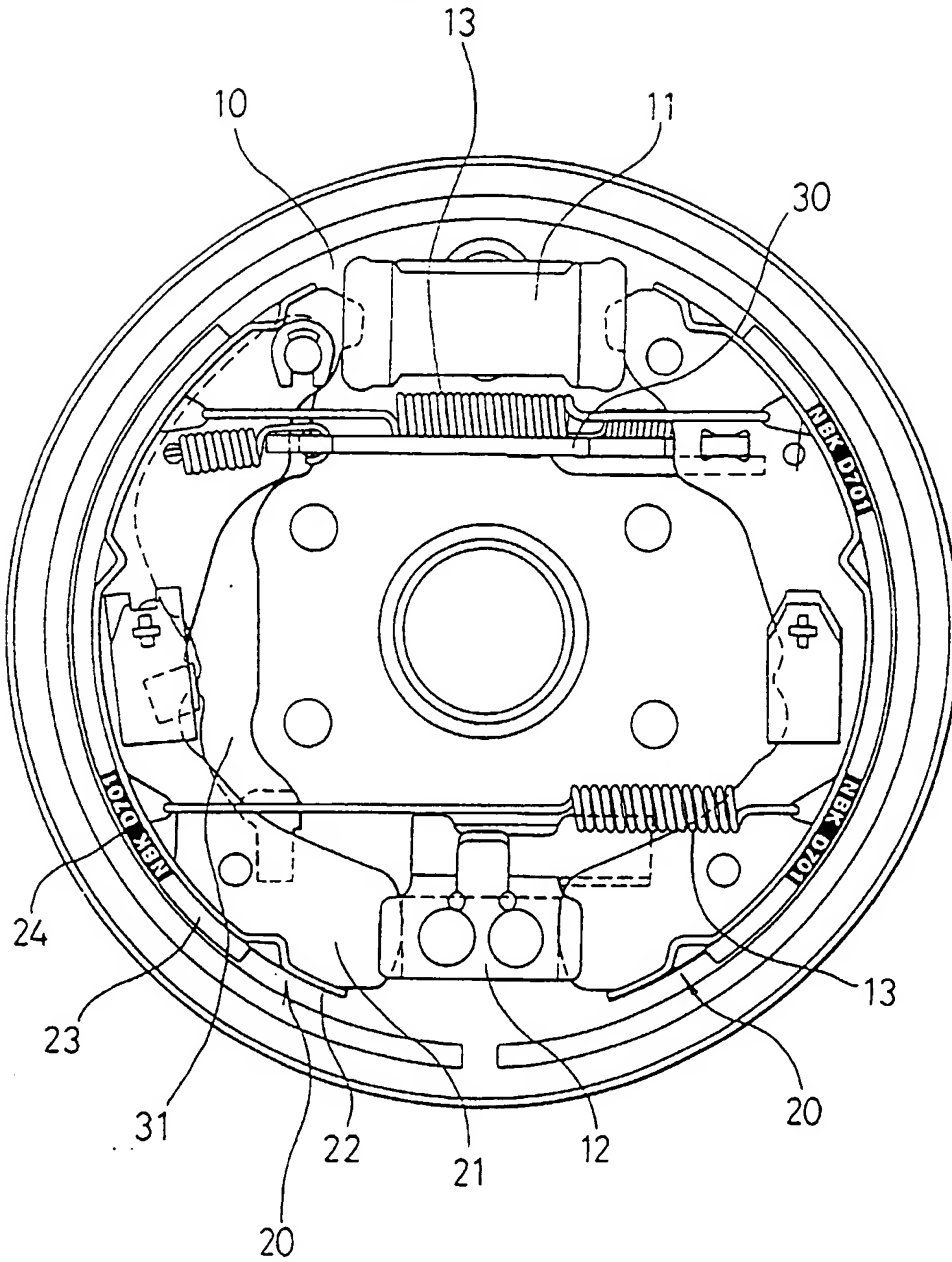
FIG. 3

[0016] Fig. 3 is a plan view of a leading-trailing type of a drum brake device, wherein the brake drum is omitted from the figure for clarity reasons. A backplate 10 is affixed to a nonrotating part of the wheel. A pair of brake shoes 20 is mounted on the backplate 10 in such a manner that they are able to expand and contract, respectively. That is, the one end of each brake shoe 20 abuts against a brake cylinder 11, and the other end of each brake shoe 20 abuts against an anchor 12 set on the backplate 10. Return springs 13 are tensioned between

the two brake shoes 20, wherein the brake shoes 20 open and expand as the (hydraulic) brake cylinder 11 expands, or close and contract due to the action of the return springs 13.

10 [0018] The drum brake device is also equipped with a mechanically-acting mechanism, comprising a brake lever 31 pivotally mounted to the brake shoe 20 shown on the left side of Fig. 3, wherein the counterclockwise rotation of the brake lever 31 causes the pair of brake shoes 20 to open and expand. This mechanism is not restricted to the type as shown in the diagram, and any conventional mechanism can be used. The components of the drum brake device are explained in detail below.

[0032] As shown in connection with the brake shoe 20 on the right hand side of Fig. 3, several coloured strips 24 can be displayed on one side face 23a of the lining 23. In this case, the coloured strips 24 should be formed symmetrically to the center of the lining 23, which will eliminate the need for bonding the lining 23 to the rim 22 of the brake shoe 20 in a certain direction, thus facilitating the fabrication process.

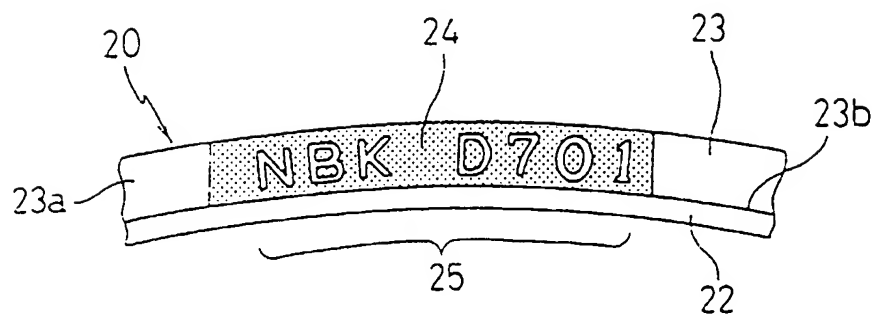
FIG. 4

[0019] Each brake shoe 20 is formed of a shoe web 21 bonded to the inner circumference of an arc-shaped rim 22 in a T-shape configuration in cross section, and a lining 23 bonded on the external circumference thereof. At least one coloured strip 24 is provided on one side face 23a of the lining 23, and a code 25 is superimposed on the coloured strip 24 to form an integrated unit. As shown in Fig. 4 of the drawings, the coloured strip 24 borders the location of the wear threshold limit value 23b which is equal to the thickness of the lining 23.

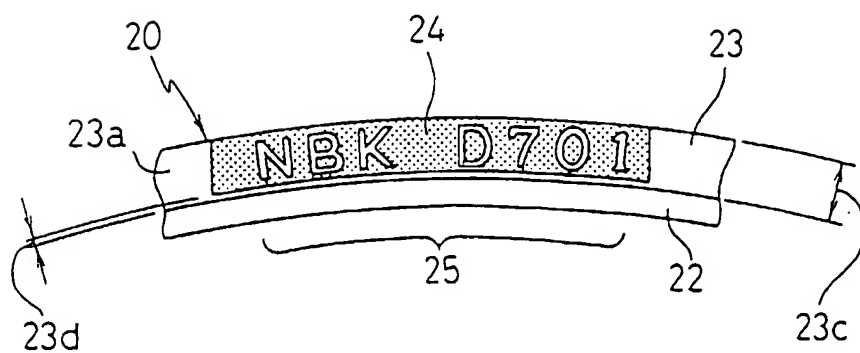
FIG. 5

[0026] Fig. 5 shows another embodiment of the invention in which the coloured strip 24 covers a depth which is equivalent to the operative abradable area 23c. In this embodiment, a contingency margin 23d is left between the rim 22 and the inner edge of the coloured strip 24.

[0027] The contingency margin 23d is left to allow for a margin of safety in replacing the brake shoe 20, and to accommodate cases where items such as rivets or bolts used to affix the lining 23 to the rim 22, protrude from the surface of the rim 22.

[0028] This second embodiment differs from the first embodiment only in the depth of the coloured strip 24 and otherwise is identical to embodiment 1 with respect to the configuration and the effectiveness of use.
